## CORROSION EXPERIENCE WITH ALUMINUM POWDER PRODUCTS

J. E. Draley, W. E. Ruther,  
and S. Greenberg

Metallurgy Division  
Programs 10.1.9 and 7.9.9

November 1963

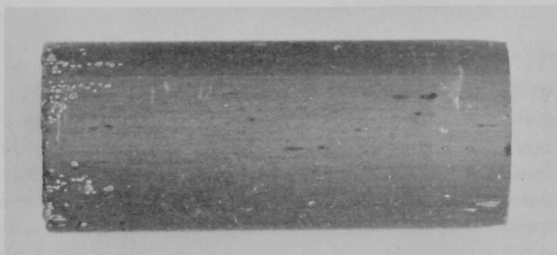
Figure 4. Beneficial Effect of Pre-corrosion Heat Treatment

It was assumed that the corrosion penetration at the ends was along unbonded longitudinal areas resulting from oxide stringers, hydrogen-filled voids, and extrusion nonbonds. To ameliorate this condition, a few specimens of the modified M654 were vacuum heat treated for 2 hr at 550°C before corrosion testing at 260°C, and compared with "as received" controls in the same autoclave. That this provided a beneficial effect is evident in Figure 4. At the end of 60 days at 260°C, the heat-treated specimen showed only a very slight tendency for swelling on one end, while the end "belling" is quite apparent on the "as received" control. A large fraction of the surface blistering was also eliminated by this treatment.

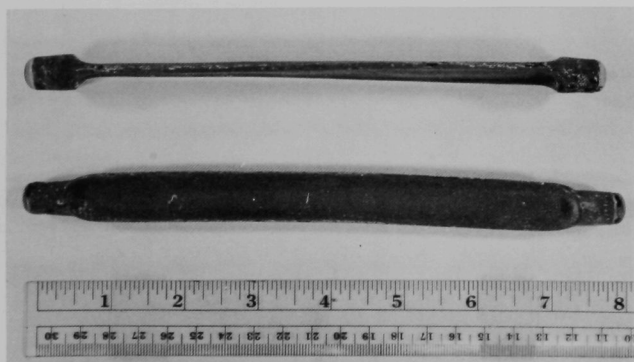
F. McCuaig of the ANL Coatings and Jacketing Group then used a "motor arc" electric welder to fusion weld the entire end of some of the tubes bonded by AI. The additional welding process greatly increased the resistance to corrosion penetration. For example, five tubes treated in this fashion were tested for a total of 292 days in 290°C water and showed none of the usual visual indications of bond failure (see Figure 13). Transverse sections of several bonded tube ends also indicated no corrosion penetration. Some of the heavy corrosion product flaked off the outside of the tube ends after long exposure, but these relatively bare spots were not attacked on subsequent exposure.

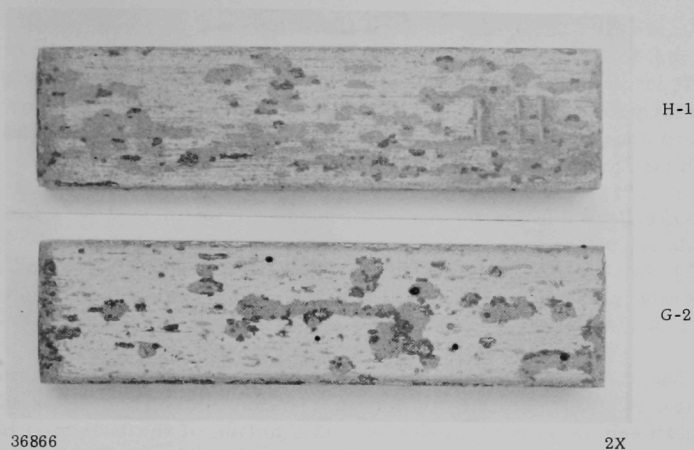
Figure 16. Trefimetaux Corrosion Specimens after 89 Days  
in 315°C Water Flowing at 5.5 m/second

Unfortunately, the dynamic corrosion behavior at 315°C (with water flowing at 5.5 m/sec) was not as satisfactory. Cones of a hard, very dark corrosion product (up to 1 mm in diameter and height) were formed on the surface of some of the specimens in as little as 30 days. The number and size of these cones increased in the order: H extrusion samples (lowest); M (intermediate); and G (most and largest). Disproportionately small pits were located under some cones; under others there were none. X-ray analysis of the cones was confused by the large number of lines obtained even after those for boehmite, the normal aluminum corrosion product, were deleted.

After 89 days of exposure portions of the outer layers of oxide tended to flake off as the sample dried, giving the appearance shown in Figure 16. The black cones previously described are particularly noticeable on the lower sample (G2).
